MISCELLANEOUS PAPER SL-85-5

SYSTEMS AND MATERIALS TO PREVENT FLOODWATERS FROM ENTERING BUILDINGS

Structures Laboratory

Final Report

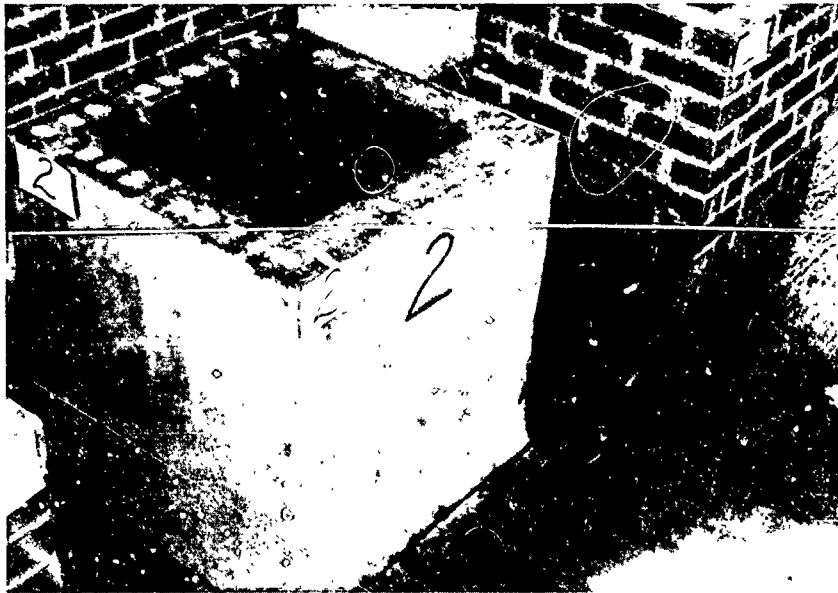
Figure 22. Initial testing of coating 4

a. Two hours after cube was filled with water

b. One day after cube was filled with water

time-consuming and thus increased the expense. It is highly desirable to use a material which can be brushed on the wall. The trowelled-on coating (coating 4) sealed the cube against a water head with only a small leak mainly at the cube-foundation interface (Figure 22). Coating 4 was not successful in terms of durability. It expanded, cracked, and began to come off the wall 3 months after it was applied (Figure 23).

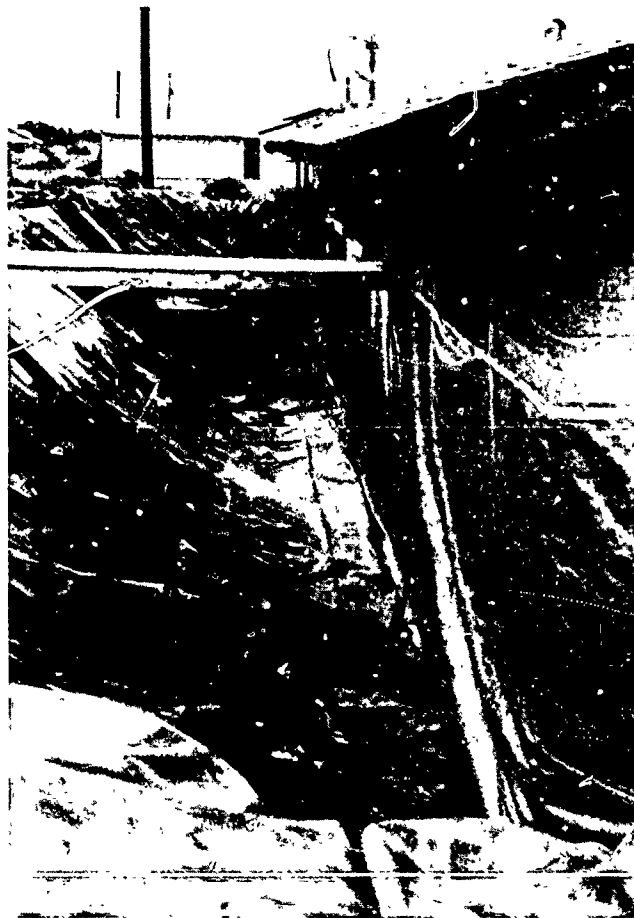
Figure 29. Plastic-over-earth berm extending down and under aluminum sealing strip

50. Plastic was placed over the earth berm and under the aluminum strip to prevent water loss through the highly pervious soil during the test. Some of the leakage problems occurred because of this installation. It was discovered that a weatherstripping material did not stick to the plastic where it was placed at the intersection of the plastic and aluminum strip. However, it should be noted that the plastic under the aluminum strip would not be present in an actual flood-resistant construction.
